Port Facility - SE Texas Rail Maintenance Test Section

Ballast Preservation

Product: **BASELOK®
BALLASTGUARD™**

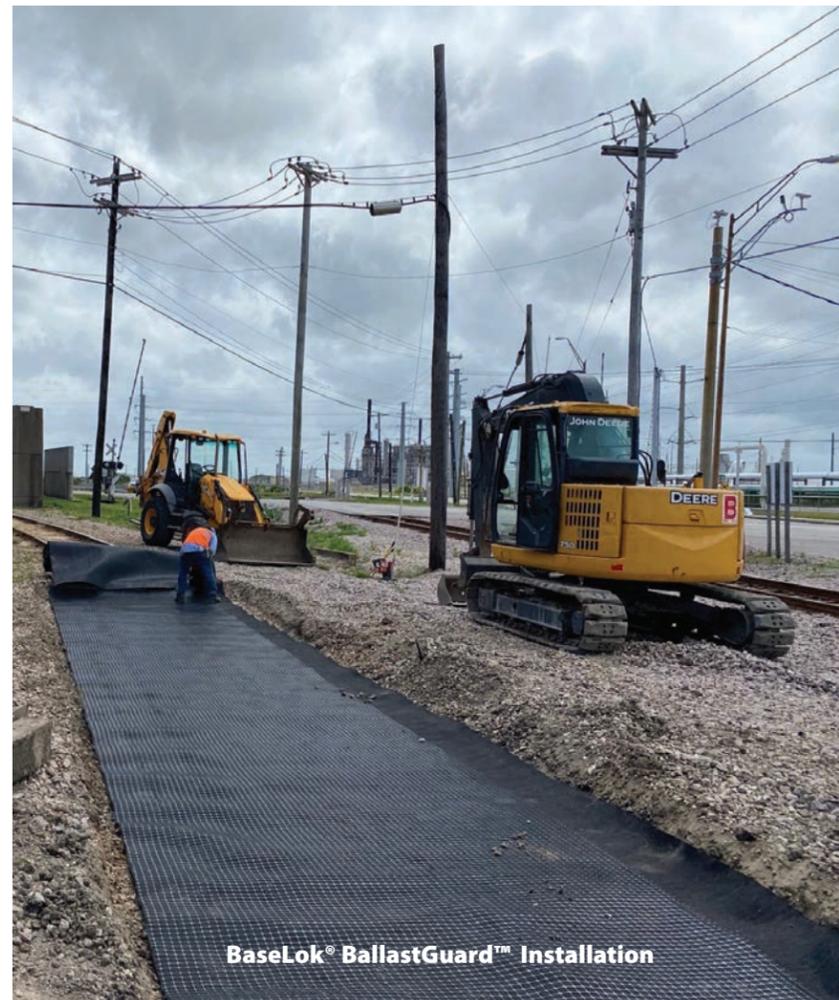
BaseLok® BallastGuard™ Installation

For our port/rail facility project, construction crews undercut the track sections, repaired the subgrade, and then placed the **BallastGuard™** material in each of the repaired sections. The placement of the **BallastGuard™** in these problematic areas protected each of the repaired sections from future pumping of fines into the subgrade, and preserved the ballast integrity.

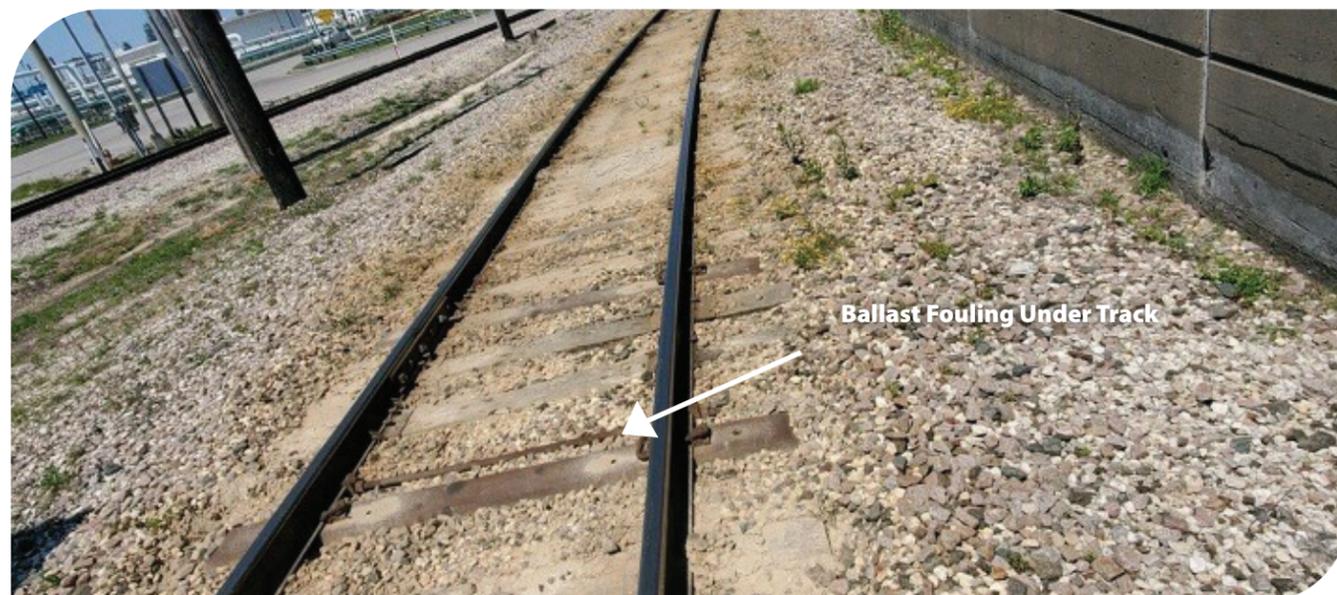
Ballast Fouling Under Track

A port facility with more than 10 miles of rail in Southeast Texas needed to address ballast that had been contaminated with fines from the subgrade. This problem known as ballast fouling, is common in areas with high silt contents and high water tables.

Ballast fouling is an issue that is challenging for rail owners to deal with throughout the United States and the world. It is caused by the pumping action created when railcars repeatedly pass over railways built over weak and saturated soils. Sites located at port facilities, oftentimes experience saturated soil subgrades, due to their proximity to water. The subgrade typically remains saturated and when the dynamic weights of loaded rail cars pass over these areas, water jets up (pumps) into the clean subballast and ballast. This water causes degradation of the subgrade with fines contaminating the subballast, thus weakening the subballast and ballast stone resulting in failures. This degradation eventually leads to potentially causing track systems to fail prematurely. As such, routine maintenance in these areas is required and often at a much higher frequency. These maintenance costs are detrimental to all rail operations.

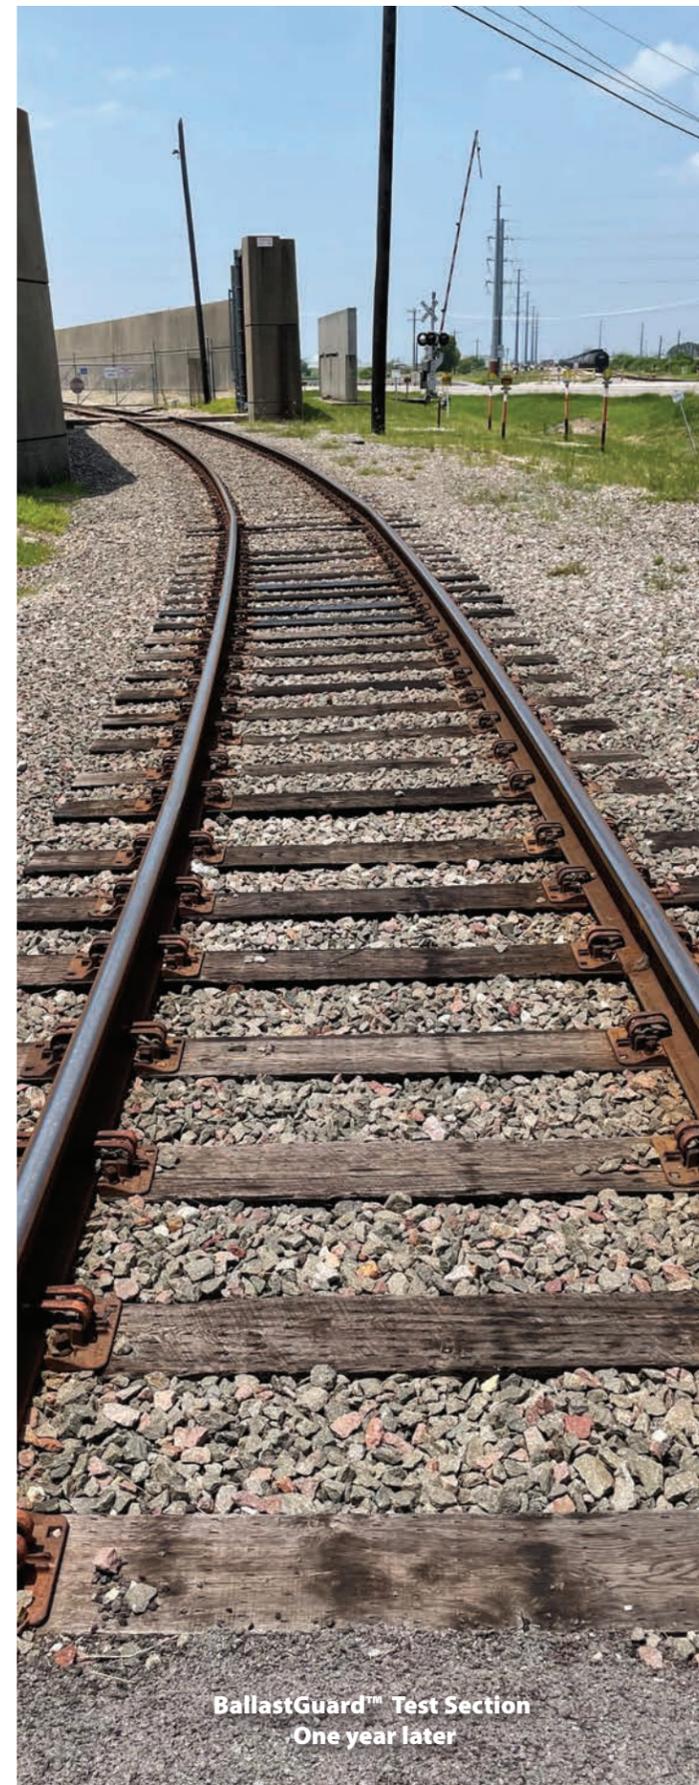
BallastGuard™ Test Section
One year later

The port manager at this facility has been extremely impressed with the performance of the **BaseLok® BallastGuard™**. This particular test section was installed early May, 2021, and no additional maintenance has been required in any of the repaired sections. Ballast preservation has been achieved in all locations where **BallastGuard™** was installed. The port plans to incorporate **BaseLok® BallastGuard™** whenever additional maintenance is needed, and will specify **BallastGuard™** on all future expansion projects.
