## Port Facility - SE Texas Rail Maintenance Test Section

### **Ballast Preservation**

BASELOK<sup>®</sup> Ballastguard

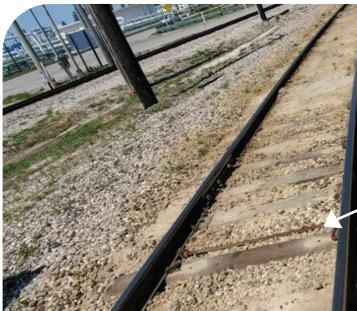
**Ballast Fouling Under Track**

A port facility with more than 10 miles of rail in Southeast Texas needed to address ballast that had been contaminated with fines from the subgrade. This problem known as ballast fouling, is common in areas with high silt contents and high water tables.

Ballast fouling is an issue that is challenging for rail owners to deal with throughout the United States and the world. It is caused by the pumping action created when railcars repeatedly pass over railways built over weak and saturated soils. Sites located at port facilities, oftentimes experience saturated soil subgrades, due to their proximity to water. The subgrade typically remains saturated and when the dynamic weights of loaded rail cars pass over these areas, water jets up (pumps) into the clean subballast and ballast. This water causes degradation of the subgrade with fines contaminating the subballast, thus weakening the subballast and ballast stone resulting in failures. This degradation eventually leads to potentially causing track systems to fail prematurely. As such, routine maintenance in these areas is required and often at a much higher frequency. These maintenance costs are detrimental to all rail operations.
